Manhole Inspection Summary

Manhole # S21II_025MH

Insp Date: **6/25/07 9:15 AM**

Location Address: **1801 FULTON AVE**

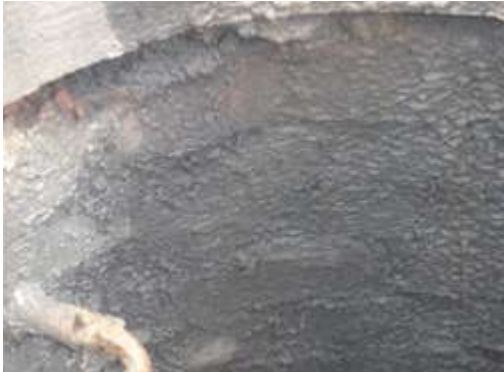
Defect 4

Infiltration: ☐ None ☐ Joint ☐ Cracks ☐ Mortar ☐ Roots ☒ **Wall**

INFILTRATION AT CHIMNEY

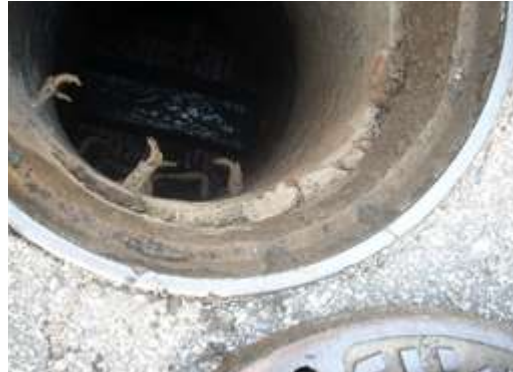
Defect 3

Frame Offset: **0** (in.) Condition: ☒ Sound ☐ Cracked ☐ Leaks

FRAME OFFSET

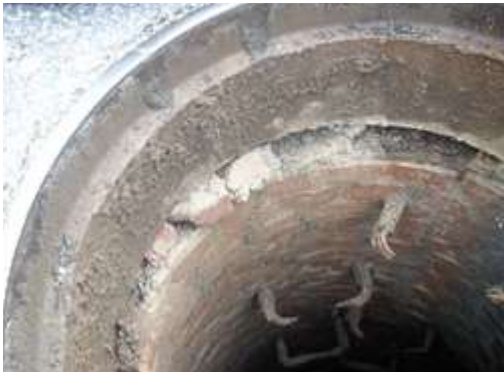
Defect 2

Condition: ☐ Sound ☐ Cracked ☐ Root Intrusion ☐ Loose Brick ☒ **Deteriorated**

DETERIORATION OF CHIMNEY

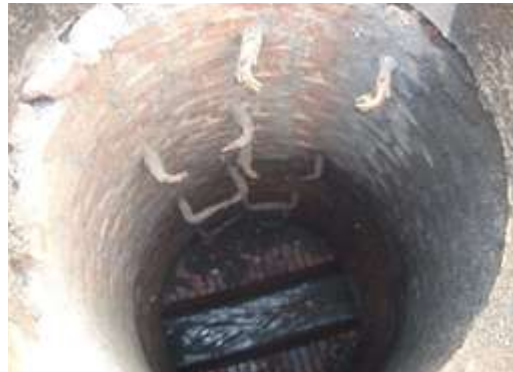
Defect 5

Steps Count: **4** Missing: **3** ☒ **Corroded**

MISSING AND CORRODED STEP

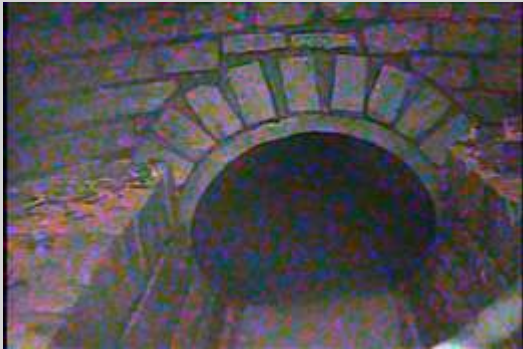
12 O'Clock Outflow

18 in. Circular Gravity Sewer
Pipe Out @ 12 O'Clock

Pipe Height: **18** (in.) Rod and Bar (Angled)
Pipe Material: **Clay** ☐ Pipe Lined
Invert Depth: **12.34** (ft.) Flow Characteristics: **Fast**
Deposits: ☒ None ☐ Mud ☐ Sludge ☐ Debris ☐ Grease
Silt Depth: (in.) Deposits Extent:
Infiltration: **None** Pipe Seal Cond: **Sound**

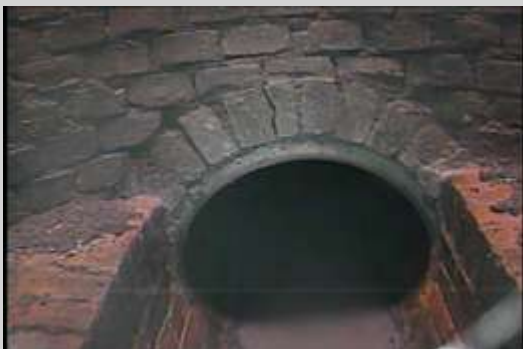
6 O'Clock Inflow

18 in. Circular Gravity Sewer
Pipe In @ 6 O'Clock

Pipe Height: **18** (in.) Rod and Bar (Angled)
Pipe Material: **Clay** ☐ Pipe Lined
Invert Depth: **12.27** (ft.) Flow Characteristics: **Fast**
Deposits: ☒ None ☐ Mud ☐ Sludge ☐ Debris ☐ Grease
Silt Depth: (in.) Deposits Extent:
Infiltration: **None** Pipe Seal Cond: **Sound**
